PROJECT: Midnite Mine Remediation

REPORT NO: 2019-028

Summary of Work Activities or Events for this reporting period:

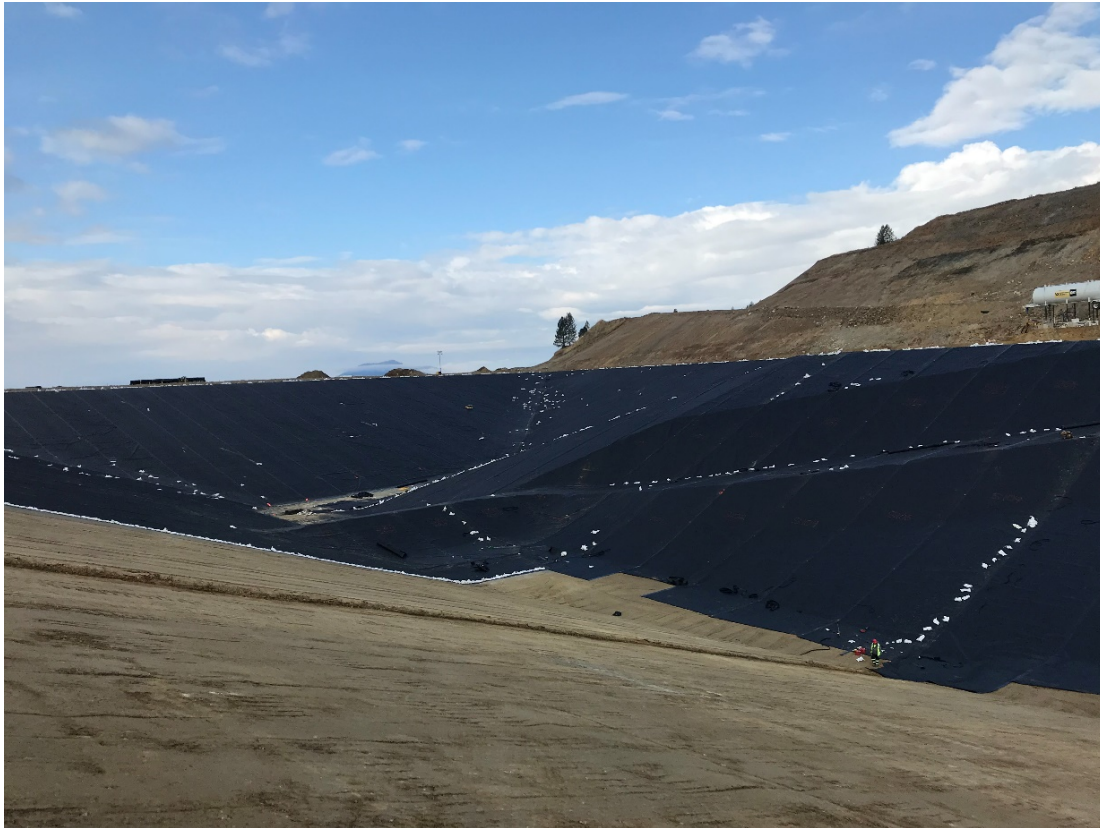
Figure 1 – Secondary Containment Liner installation in South Pond looking northwest on October 4

- Felled trees along the alignment of the overhead powerline for the South Pond Pump Station.
- Tetra Tech/AEG continued installation of the High Density Polyethylene (HDPE) Secondary Containment Liner and began installing geonet in the South Pond. Preparation of the South Pond subgrade and excavation of the anchor trench were performed concurrently with liner installation to minimize the amount of rework required if a significant rain event were to occur. Pea Gravel was placed in the east Leak Detection Sump.
- Pit 4 tension crack was measured on October 7. The horizontal distance between movement pins remains at 53.75 inches, indicating no measurable movement.
- Herrera arrived on Site and began planting shrubs and trees in the West Access Road area.

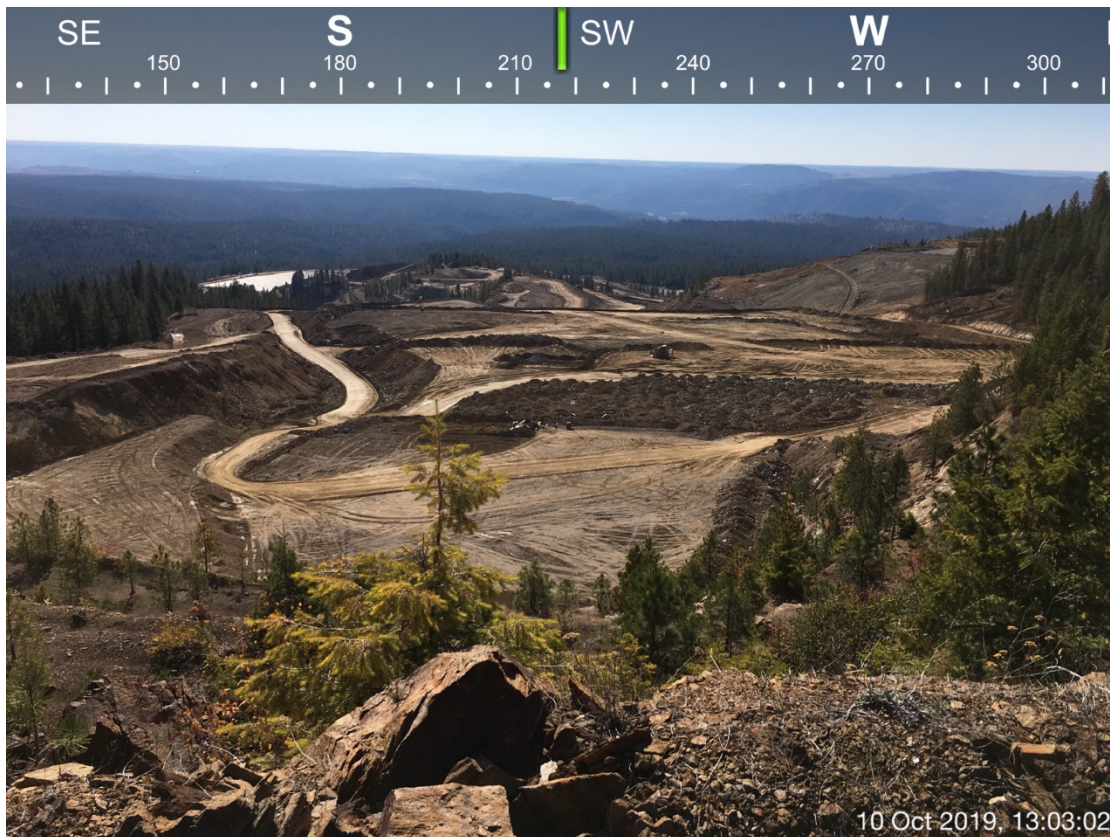
Figure 2 –Pit 4 overview looking southwest.

- Continued excavating, hauling and placing low activity/low reactivity material to Pit 4 from the west and north sides of the South Waste Rock Pile (SWRP). Material from SWRP was placed in the Pit 4 Waste Containment Area (WCA).
- The above materials were excavated with either excavator or loader equipment and transported and plug dumped with haul trucks. The plug dumps were leveled with a dozer into lifts not exceeding 10' thick. Table 1 presents the 2019 Pit 4 mass haul material volume.
